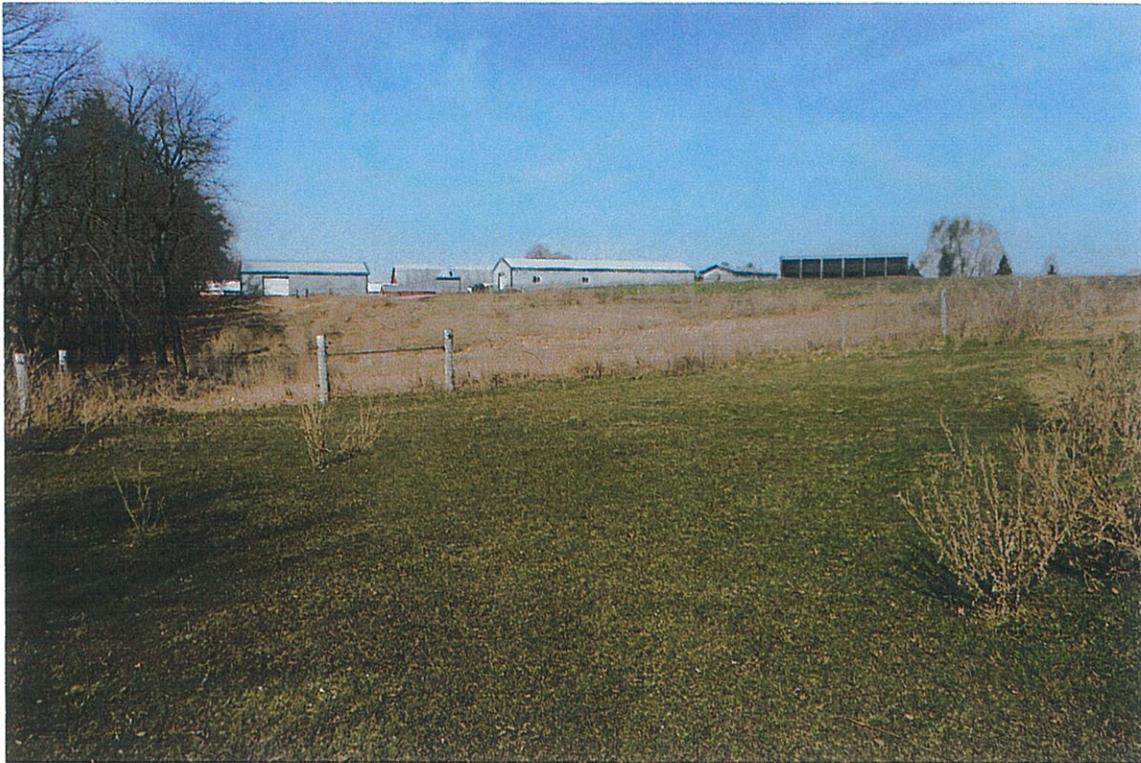
Photo 5-Looking northwest from near southeast corner of Parcel 1. Note shed to far left and cycle building distant center. Area in foreground contains piles of horse manure.

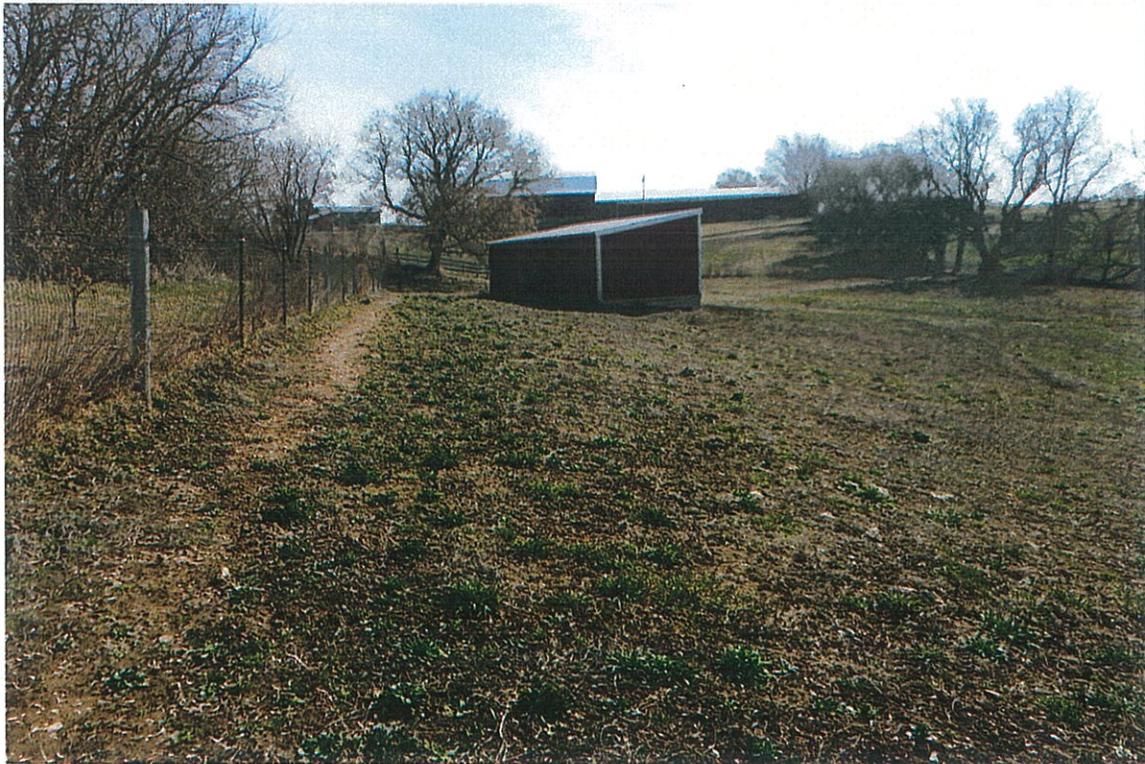
Photo 8-Looking east along northern Property line from near midpoint of Parcel 2. Note horse shed in photo center and barn and horse arena in distance.

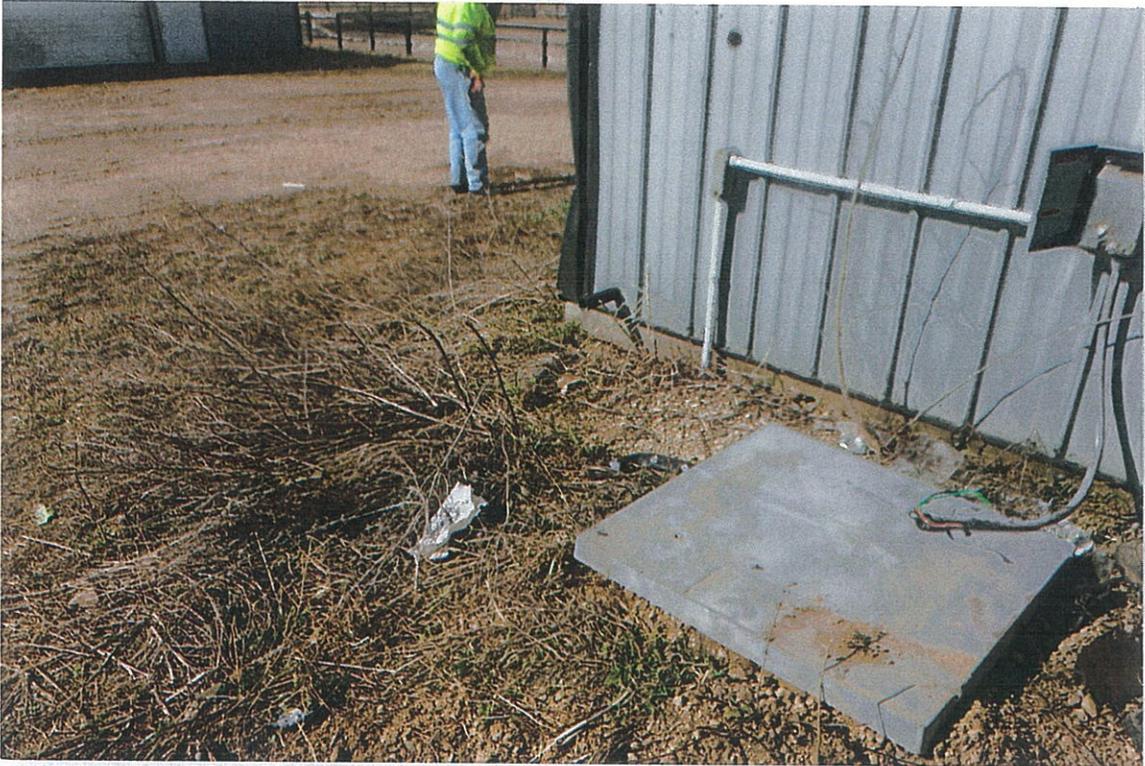
Photo 9-Looking at southeast corner of cycle shop. Note small diameter pipe in photo center which appears to be a drain pipe from a sink located in the southeast corner of the building (see Photo 10).

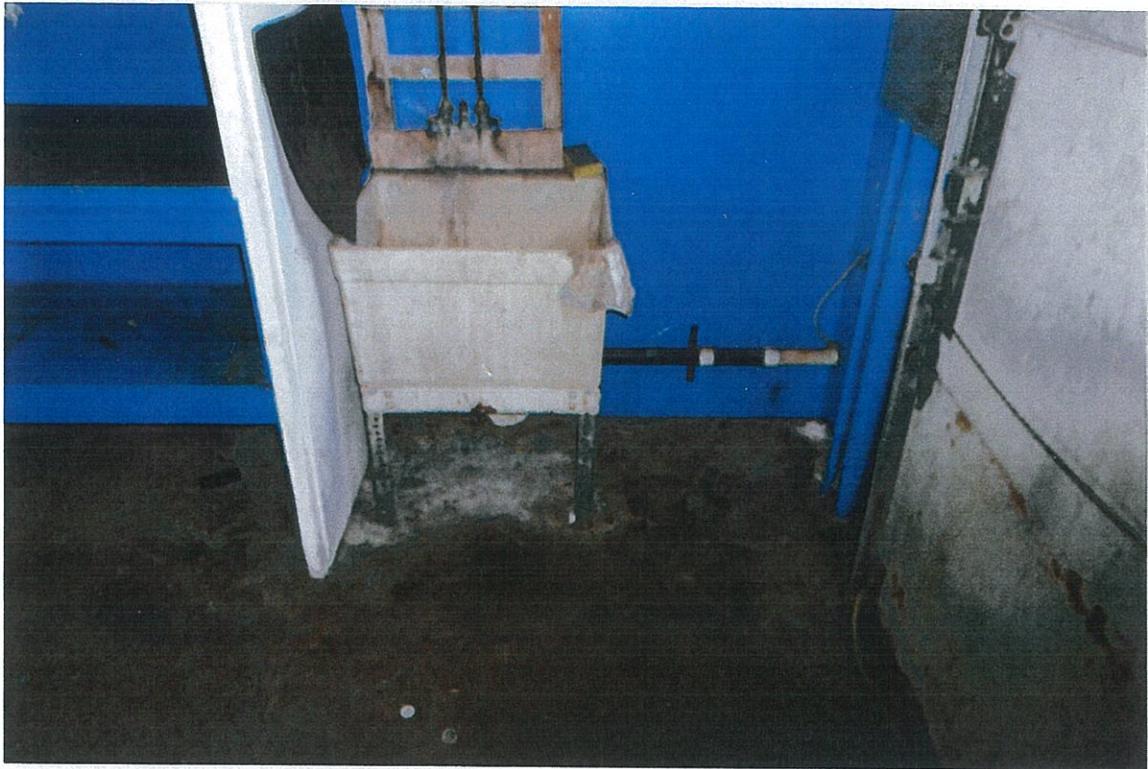
Photo 10-Looking at sink in southeastern corner of cycle building. Note drain pipe extends through wall and exits as noted in Photo 9.

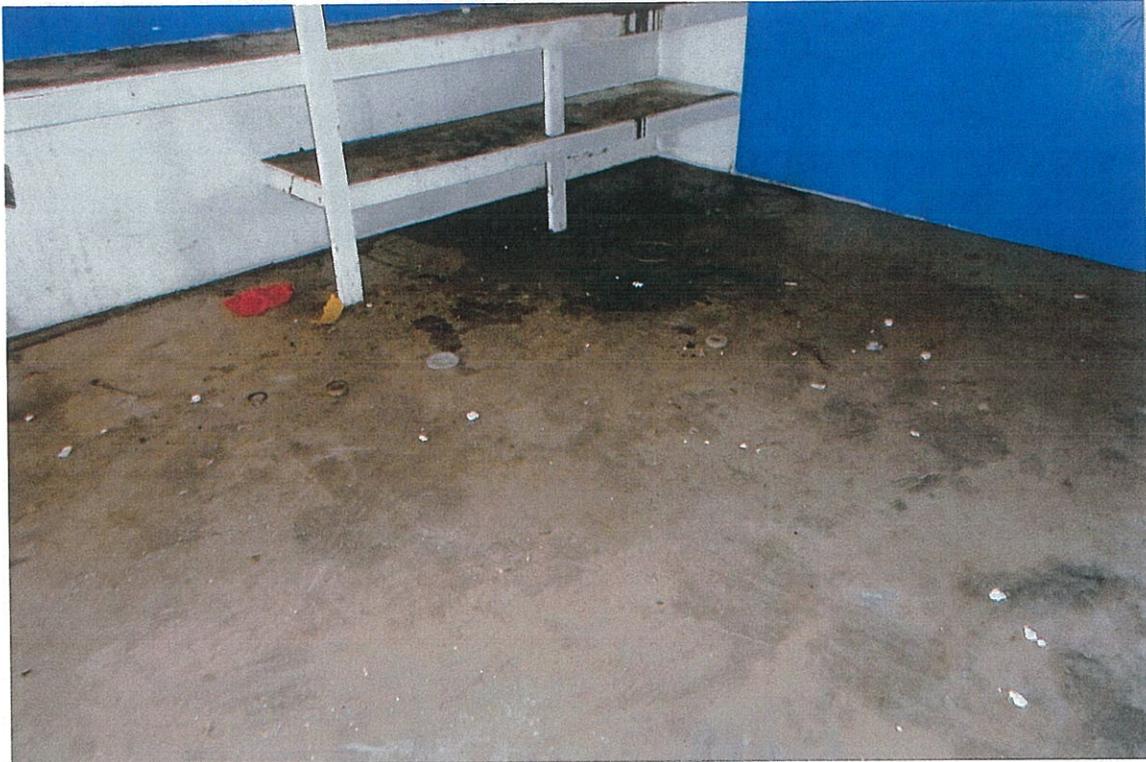
Photo 11-Looking at former waste oil drum storage area inside cycle building. Note some limited staining of concrete.
